SERVICE ADVISORY 016-0029

Subject: Evolution Main Gear Trailing Link Bushing

Date: May 20, 2016

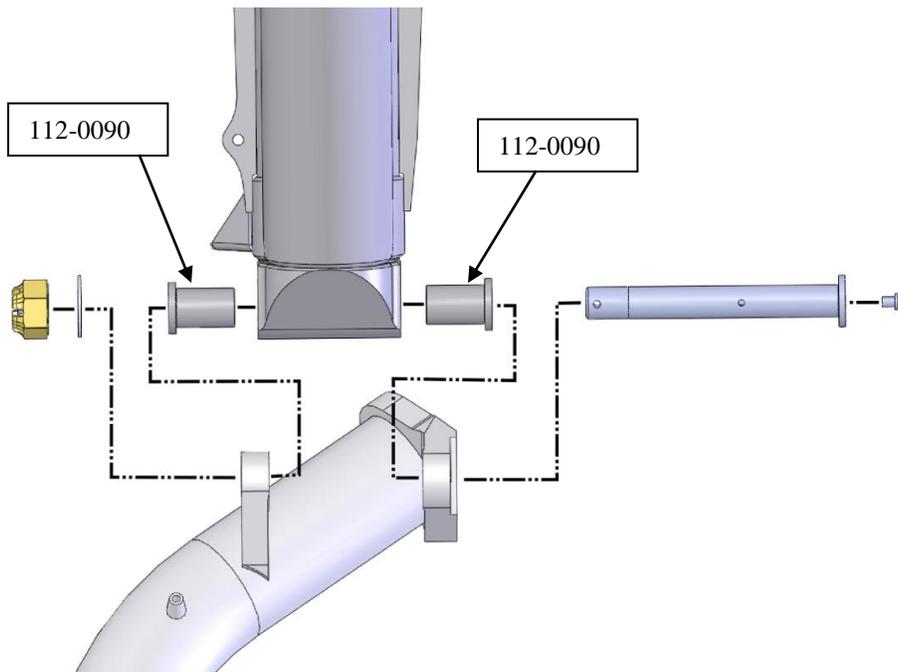
In certain cases, the trailing link bushings (112-0090) have exhibited excessive wear over time. We have changed the bushing material and quality inspection methods to minimize wear of the bushing.

At the aircraft's next condition inspection (annual) we advise you to inspect these bushings for wear or slop in the trailing link. If excessive wear or slop is spotted please purchase new bushings from KCI. These bushings should continue to be inspected at each condition inspection for the aircraft.
