SERVICE BULLETIN

SB016-0031

Subject: Improper Installation of 90° Fitting on the Actuators

Date: 12/7/2016

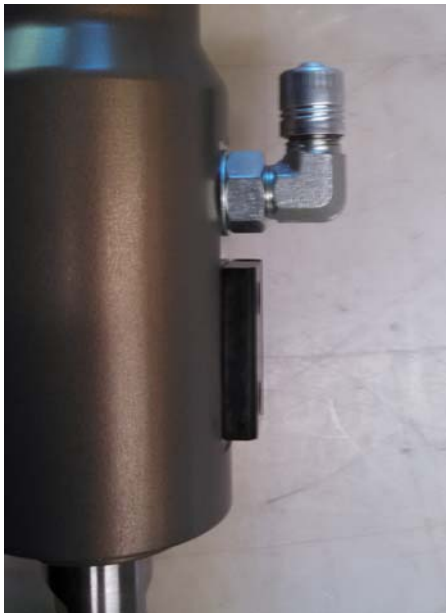
During the installation process, the 90-degree fitting on the up side of the actuators may have been removed or altered from their original assembly to make the lines fit. These fittings were designed to have only one thread of play and it is very important that the fittings have been properly installed on your aircraft.

Fitting backed off 1 thread.

First the aircraft will need to be lifted on jacks, and then the hydraulic line removed from the up side of the actuator. Temporarily remove the 90-degree fitting and make sure the metal sleeve is positioned such that the slot in the sleeve is placed over the fitting hole, this can be done using a small flat head screw driver. Replace the fitting and screw it in until it bottoms out. When reattaching the hydraulic line, if needed, only back the fitting **out no more than 1 thread** (approximately $\frac{3}{4}$ turn), then tighten down the nut (snug plus $\frac{1}{4}$ turn). This will need to be completed on all three actuators. **Note: This Service Bulletin does pertain to ALL Evolution actuators.**

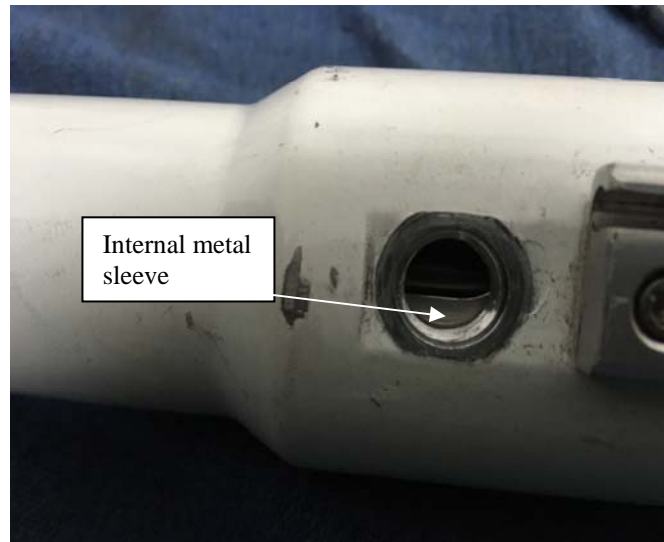
We have identified a potential situation where the gear actuators may have been improperly installed during the build process and over time the inner sleeve of the actuator can rotate. If this inner sleeve rotates, it is possible that the sleeve will block the 90-degree fitting thus locking the actuator in the up position. Since there is no way to determine when this sleeve might move or the process that builders might have used during installation, we would like you to inspect all three actuators and verify that the installation of the 90-degree fitting has been done properly. Even if you have flown your Evolution for many hours this could still be an issue. If the fittings were improperly installed on your actuators, and the internal sleeve rotated, the emergency gear drop procedures may not work.

The metal sleeve shown has slid out of position.
