Document Title	Evolution Nose Gear Actuator Attachment Modification
Document Number	SB 016-0009
Date	October 14, 2011

Subject: Nose Gear Actuator Attachment Modification

Affected Aircraft: Lancair Evolution Aircraft Serial Numbers: EVO-001 - EVO-0035

Status: Mandatory Service Bulletin for all Lancair Evolution aircraft

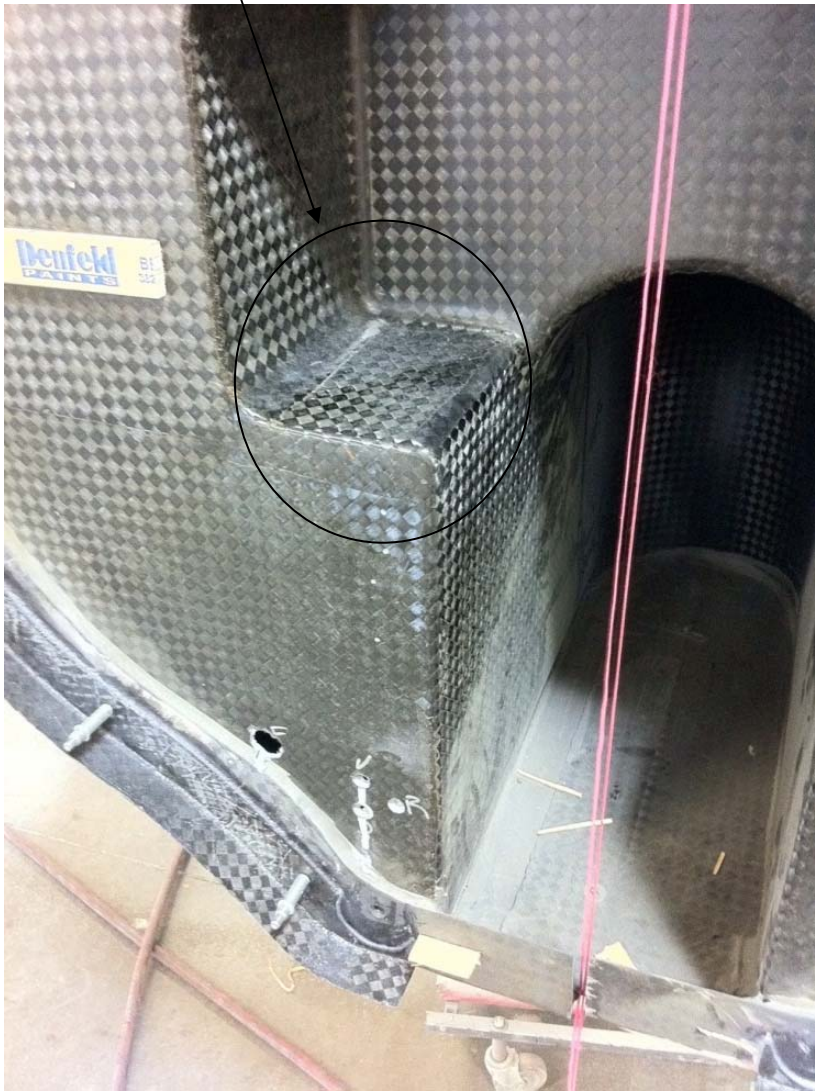
Oper.	Description	Hrs.	Date	Oper	Insp
010	<p>As necessary for inspection of the outer face sheet area shown in the picture below, remove the nose gear actuator lug and firewall blanket, then visually inspect and tap test the laminate structure of all faces adjacent to this corner looking for any damage from heavy nose gear landing loads.</p>

<p>Note: It is possible that damage sites may be present several inches in any direction from this corner.</p>

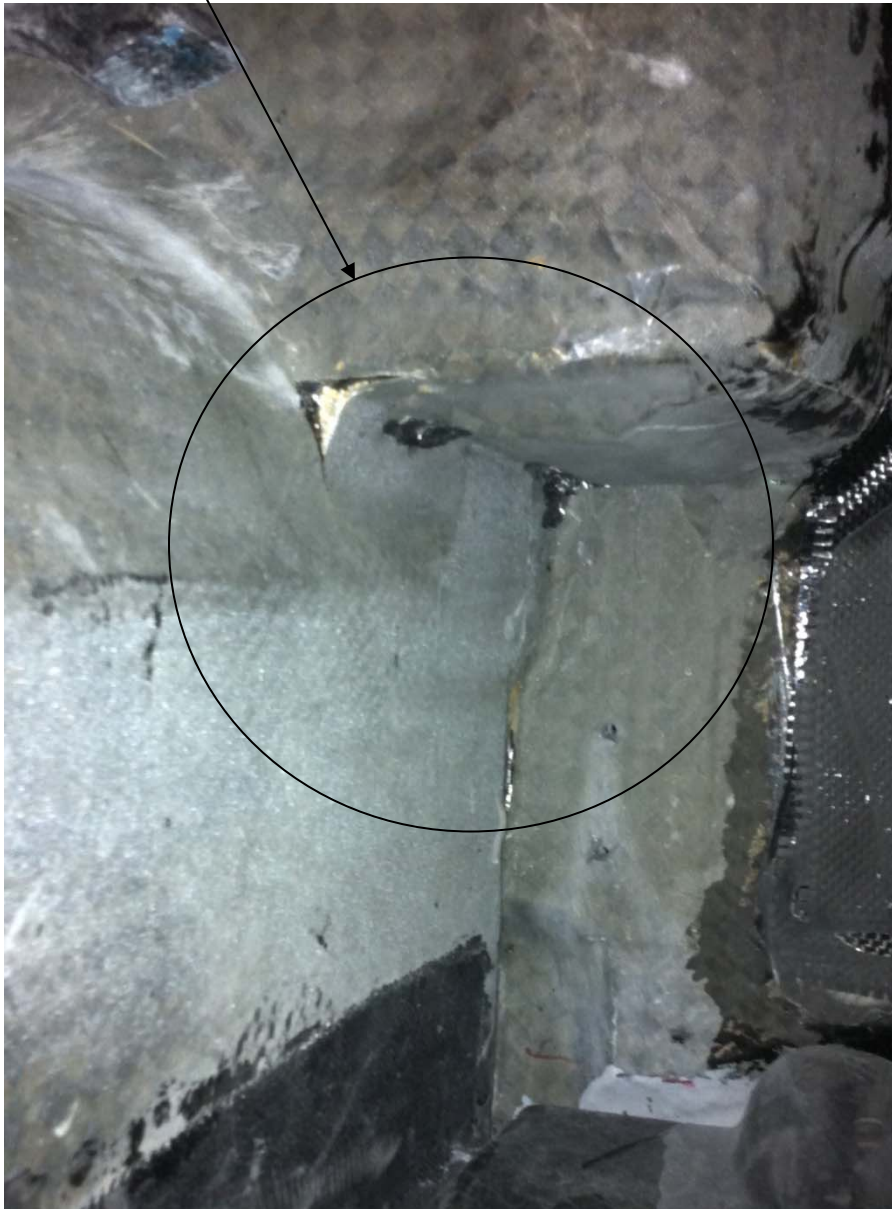
As necessary for inspection of the inner face sheet area shown in the picture below, remove the interior, equipment and furnishings, then visually inspect and tap test the laminate structure of all faces adjacent to this corner looking for any damage from heavy nose gear landing loads.
