<b>Document Title</b>	Evolution Lower & Upper Ice Door (Inertial Separator) Reinforcement
<b>Document Number</b>	SB016-0016
<b>Authors</b>	Larry Hinman
<b>Date</b>	01-22-2014

**Subject:** There have been several known instances where the Lower or Upper Ice Door (Inertial Separator) face assembly has separated from the mounting tube or cracks have appeared at the weld points.

**Affected Aircraft:** All Evolution aircraft

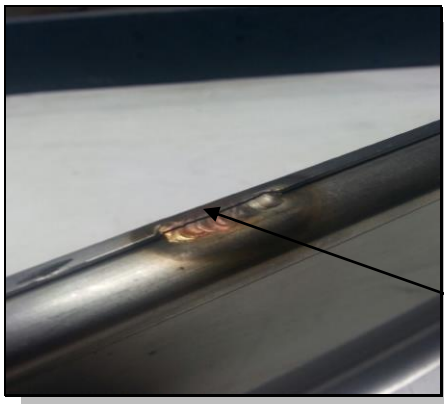
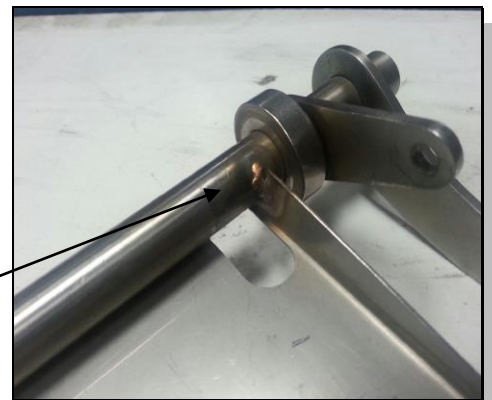
**Example of Cracks in Welds**

**Action:** To identify if your Ice Door(s) (Inertial Separator) is affected, inspect the door where the door face plate is welded to the pivot tube. Check for detachment of the face from the rail and or cracks in the weld points. Call LANCAIR Parts Department 541-923-2244, for a RMA number to return the damaged Ice Door(s). Lancair will either replace or upgrade (depending on part availability), one or both doors for \$200.00 (cost of parts and labor).

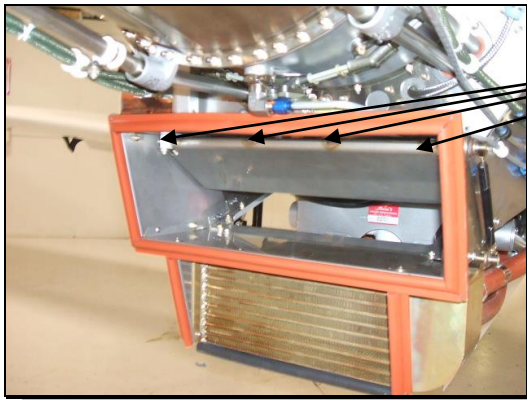
p/n: 251-0171  
Upper Ice Door (Inertial Separator)  
Inspect these weld points for  
cracks
