## SERVICE BULLETIN

**SB016-0025**

Subject: Main Gear Door Hinge Service Issue

Evolution Main Landing Gear Hinge & Bolt Replacement

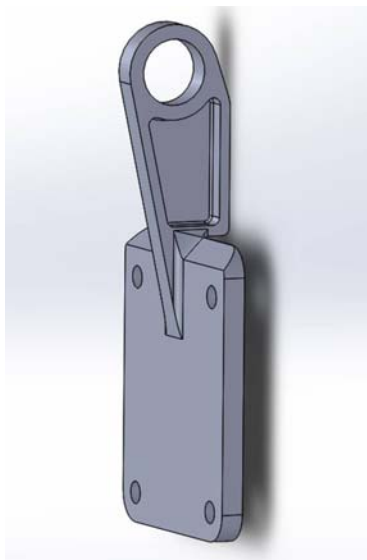
Picture 1 shows a chamfer at the end of the hinge, whereas Picture 2 shows a square edge. Once you identify the hinge needed, please contact Lancair at 541-923-2244 and ask for our parts department to order the proper hinge & bolts.

The main landing gear hinge has had two versions with different hole locations. You will need to determine which hinge is currently installed. Below are pictures of the two hinges that are currently in service. Please compare these pictures to the hinge on your aircraft. Replace the small link-to-trunnion attach bolt on each gear leg as well.
