Information for the Evolution Owner and Builder

Redmond, OR; July 14, 2015

Possible nose gear unlock during parking update.

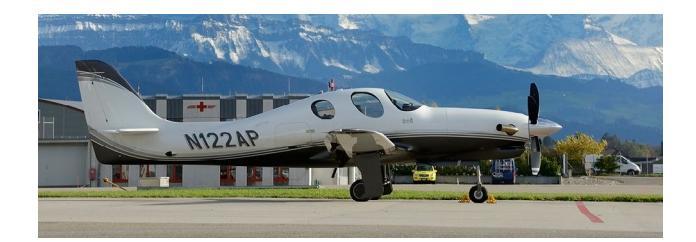
Proper Procedure for Servicing of the Hydraulic Accumulator on kits #60 and above or earlier kits with the Increased Gross Weight Actuator Installed.

We have become aware of some technicians not following the proper accumulator pressurization procedure. To properly pressurize the accumulator after any landing gear system service, follow this procedure:

The point is that the accumulator needs to be pressurized with the gear DOWN after an up-cycle. Always check for leaks from the actuators. They should not leak at all and a leaky actuator should be removed from service. EVOLUTION owner's

Revised Hydraulic Accumulator Charging Procedure Note: may be done with aircraft on wheels

- 1. Elect. Power OFF
- 2. PULL Hyd Pump CB, Verify Gear Relay CB IN
- 3. Elec. Power ON
- 4. SLOWLY open Maintenance (dump) Valve until fluid begins to flow and wait for flow to stop
- 5. FULLY OPEN Maintenance Valve
- 6. Attach Nitrogen Source and charge to 800-850 psi
- 7. Disconnect Nitrogen Source
- 8 CLOSE Maintenance Valve
- 9. Push Hyd Pump CB and allow to run until flow stops.
- 10. Power OFF (if desired)

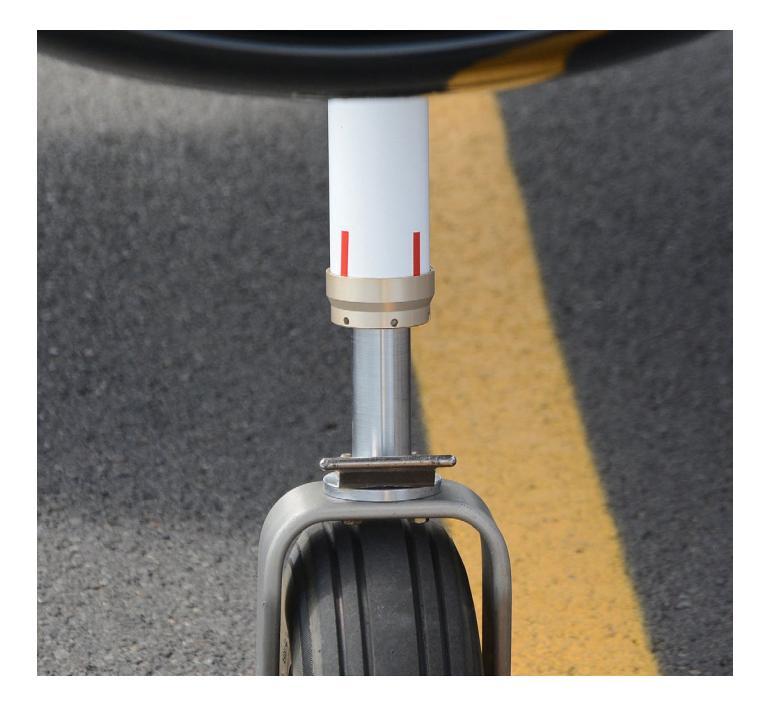
Nose Gear Collapse on Landing Incident.

Many of you read of the nose gear collapse on N3WB at KSQL last fall. It was the topic of a couple safety related blurbs in the aviation media and has been discussed among owners. There has been more than one question posed to us as to the cause of this incident and why we are not addressing it. The answer is that we do not know exactly what happened or why, and are waiting for the NTSB to release their report. This process is a bit different from the norm in that the NTSB were "on

site" right away and took control of the damaged parts. Their labs are doing the analysis of the broken parts and will release their findings as to what failed. Bob Wolstenholme is a "party to the investigation" and will be advised of their findings. There is a supposition that what will be found is a damaged shimmy damper that allowed the gear to go into a diverging shake which overstressed the trunnion, causing it to break at the hinge pin. A part of the supposition is that the subject airplane had just come off a very long multi-stop trip with many landings where many FBO's had an opportunity to tow the aircraft. It is possible that one of those may have overturned the nose wheel, damaging or breaking the damper. As a reminder, your POH lists a limitation of 50 degrees each way from center for the nose gear. I personally inform each FBO that I visit that it is 45 degrees and to observe that limit. We are having some limit stickers made for your strut and when they are available we'll send them out to you. In the meantime, a nice strip of red tape on each side of the strut wouldn't hurt.

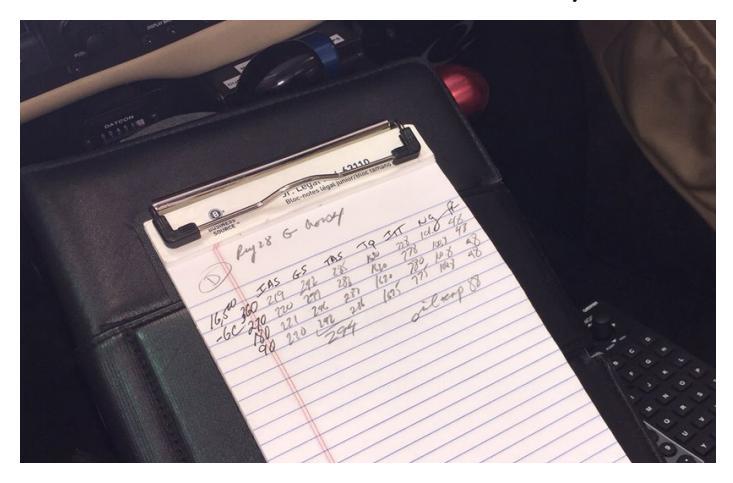
This data need not be complicated. In this actual example, note that zero wind ground speed is 294, while the average TAS is 286.

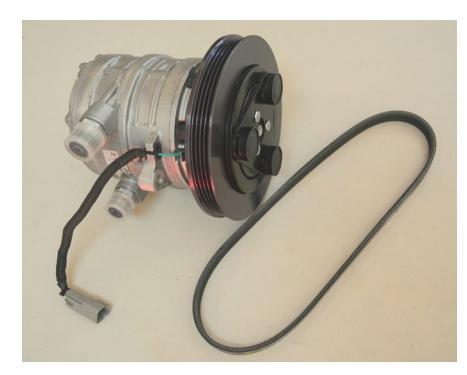
When the Evolution kit was first spec'ed out, an air conditioning compressor was chosen that "fit" and was more or less properly sized to do the job. During one of the projects that we have undertaken over the last couple years to improve the system, we found that the A/C compressor, although optimal in nearly every way, was

operating at the very high end of its' rpm efficiency "map". That is, it was spinning too fast to compress the A/C fluid to a "best" pressure. It needed to be slowed down to perform better and last longer.

Unfortunately, there was not a larger pulley available for that compressor, and the drive pulley on the engine pad could not be made any smaller to decrease the rpm of the compressor. The solution was to machine the stock pulley down to a "hub" and make a larger pulley "ring" that could be installed onto the hub. We did that, and have been running a so equipped compressor on N424SM for about 300 hrs. with excellent results. The A/C works very well and there have been no issues with the set-up. We have installed a similar set up on another demo aircraft to prove the modification and installation process. It will be available to you by sending your compressor to us so we can install the larger pulley ring. Other than the R&R of the compressor, this is not a do it yourself or locally available process due to the special pulley and machining process. It will be returned modified and accompanied by a longer belt. New compressors are not all that expensive, so you might consider having the mod done to a new one and keeping your current compressor for a spare since the mod will cost the same whether we do a new one or yours. Using a new one would give you a spare on the shelf. Pricing is still being formulated. Call Kim for an update in a couple of weeks.
