SERVICE ADVISORY

SA016-0028

Subject: Evolution Nose Gear Tow Warning Decal

Date: March 21, 2016

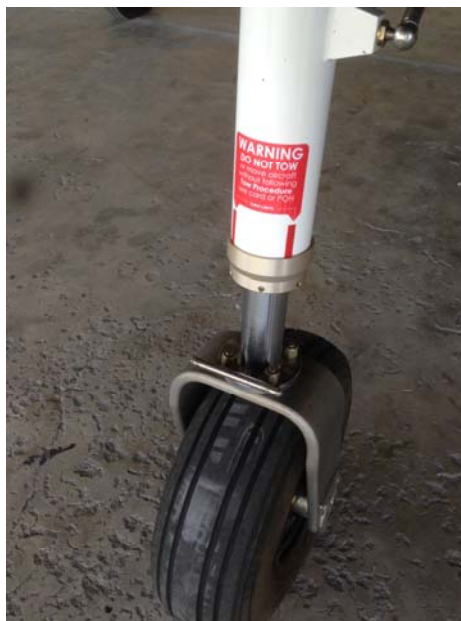
Shown is the finished result.

To apply the tow warning decal, locate the center of the strut with the nose straight. Temporarily place the decal such that the center mark is in the nose wheel straight position. If you are unsure it is placed in the center, remove all weight from the nose gear and the strut will self-center. Adjust the decal as necessary. Once placed in the correct position firmly press to finish applying the decal.
